New World Order: Manipulated Certificates

Certificate's title: „*Pollutant survey (Asbestos, PAH and PCB)*“

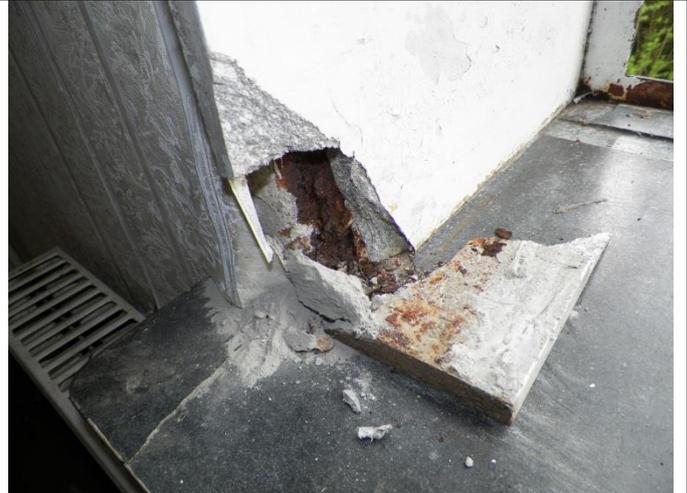
This asbestos-containing window covering was not described in the expert report - which was never discussed.

Broken out (to be able to detect asbestos) and crumbled (to show how harmless it was) the piece had a friend of my ex-husband (a construction engineer). The appraiser was terrified. Crumbling is forbidden in asbestos.

According to purchase receipts, there was only this one window covering made of asbestos.

Afterwards, as I discussed with the appraiser, I removed the asbestos with protective clothing, protective mask and a lot of moisture and airtight sealed the place with plastic film.

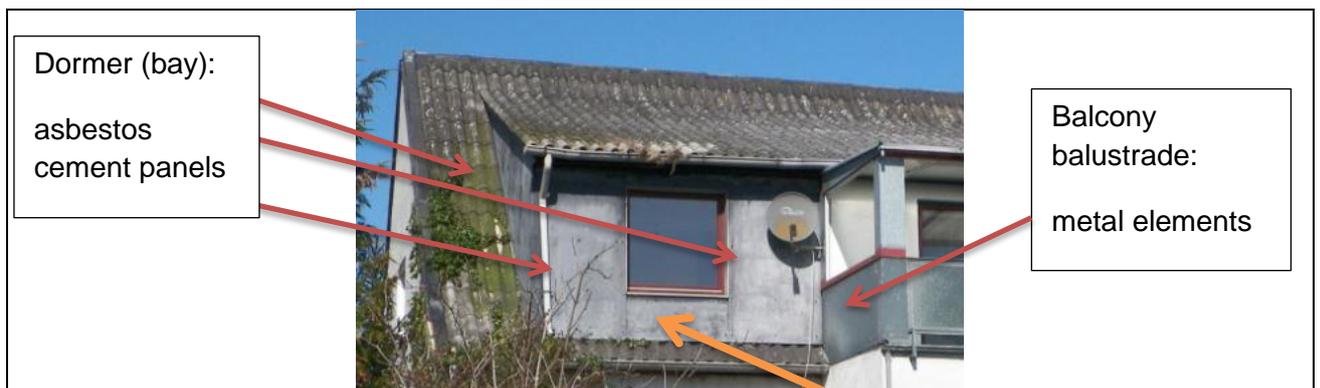
Real Situation:

Page 11: "External facade bay window: metal elements, windows at the bay window clad with asbestos cement panels." -> this describes twice the same place, but with other materials

When the appraiser was on site she scratched with her key on the plates that were screwed to the dorm and said it is metal (= sheet metal). The asbestos disposal manager was horrified about this scratching when I told him later on his second visit. Scratching is forbidden with asbestos.

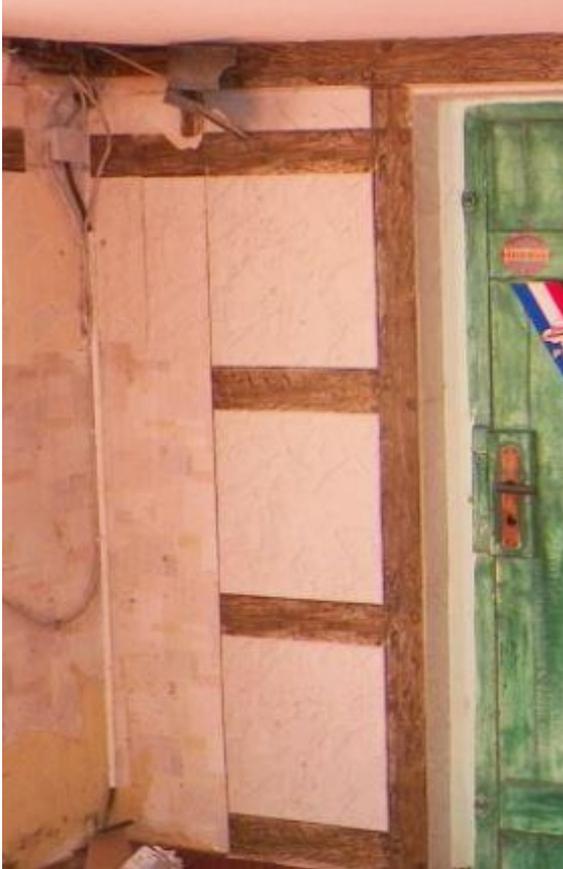
Wallpaper during the inspection:

Page 12: "On the ground floor there are visible wood (timber frame, wooden beam ceiling)".

This is not correct. It was a wallpaper, which I had also said and shown to the appraiser.

The building is made of hollow concrete blocks. A timber frame on the ground floor would not have been able to bear this in the long term. The ceilings are reinforced concrete constructions.

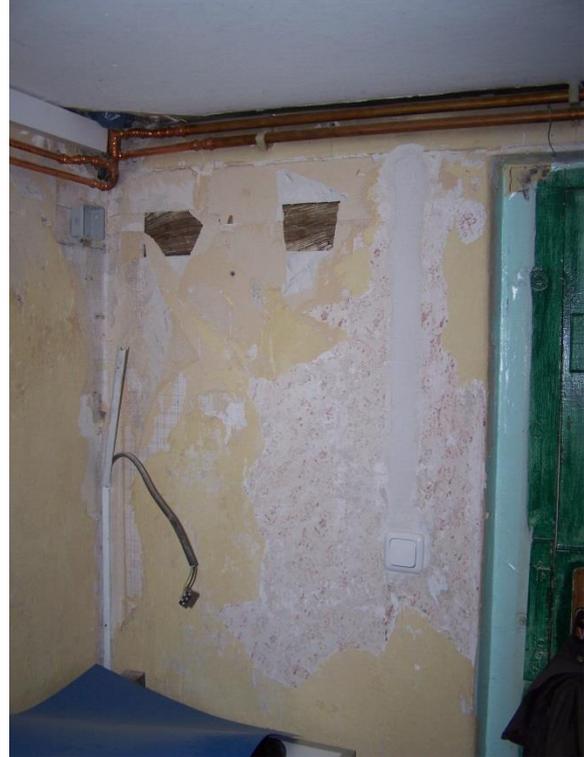
Today:

The wallpaper was removed so that the heating engineers and electricians could work. This is how "German standard" looks today.

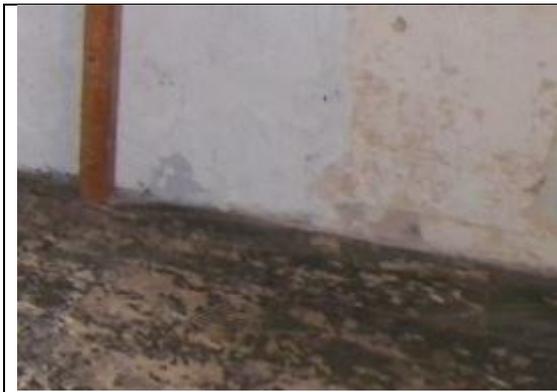
<p>By phone we agreed to send again a sample of the glue with adherent asbestos plate. There was only that half-plate. In the glue was visible also a small fragment of the plate, therefore I hoped that it would perhaps be cut off beforehand with laboratory tools. In this second test (after finishing the certificate), asbestos was found in the plate as well as in the adhesive. The expert asked if I would sell the house now.</p>
---	---
